分類/Classification	<input type="checkbox"/> tDS	<input type="checkbox"/> tGW	<input type="checkbox"/> PETL/tET/tPET	<input type="checkbox"/> DS/PDS/PPDS	<input type="checkbox"/> tM-752N
	<input checked="" type="checkbox"/> I/O Card	<input checked="" type="checkbox"/> VXC Card	<input type="checkbox"/> VxComm	<input type="checkbox"/> Other	
作者/Author	Dan Huang	日期/Date	2024-09-23	編號/No.	FAQ-027

Q: Error code 39 occurs when installing the driver in Windows 10/11 or the driver cannot be loaded?

A: Disabling Core Isolation in Windows 10/11 to Fix Driver Error Code 39

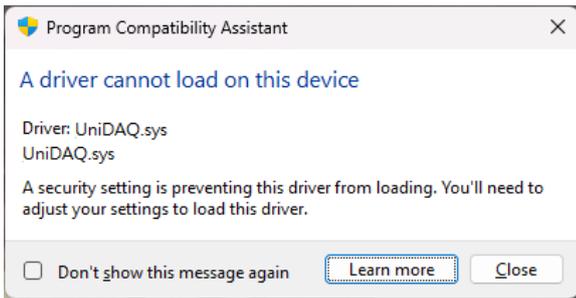
▲A driver cannot load on this device

If you encounter driver error code 39 when using the driver, the issue may be caused by the Windows 10/11 **Core Isolation** feature, specifically the **Memory Integrity** setting. This security feature helps prevent unauthorized access to high-security processes, but it can also block certain drivers. To resolve this issue, you need to disable **Memory Integrity** under **Core Isolation**.

1. **Open Windows Security:**
 - Press Windows + I to open the **Settings** app.
 - Navigate to **Update & Security**, then click on **Windows Security** in the left menu.
2. **Go to Device Security:**
 - In **Windows Security**, select **Device Security** from the menu.
3. **Open Core Isolation Settings:**
 - Under **Core isolation**, click on **Core isolation details**.
4. **Disable Memory Integrity:**
 - Turn off the toggle under **Memory Integrity**. Disabling this may require a restart.
5. **Restart Your PC:**
 - After disabling the feature, restart your computer to apply the changes.

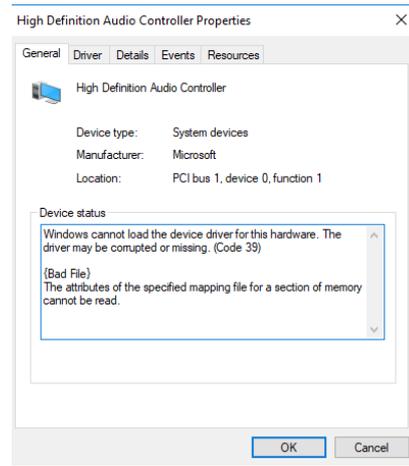
▲Error Code 39
