# tGW-700 Series

## Firmware Update via Ethernet

Version: 1.2/ Updated: Nov. 2014

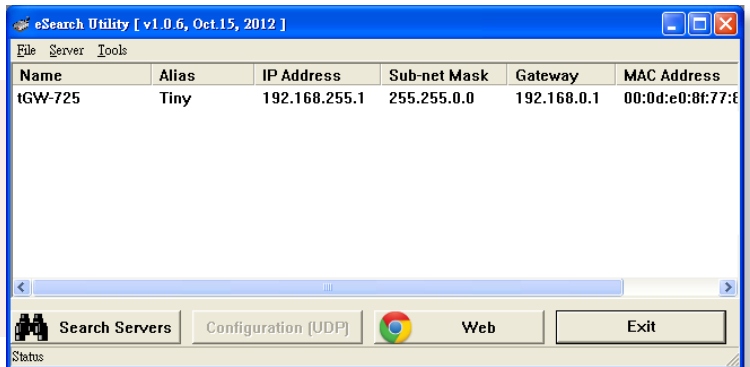
**Step 2: Install the eSearch Utility on your Host PC, and then run the Utility to search for any tGW-700 modules connected to the network.**

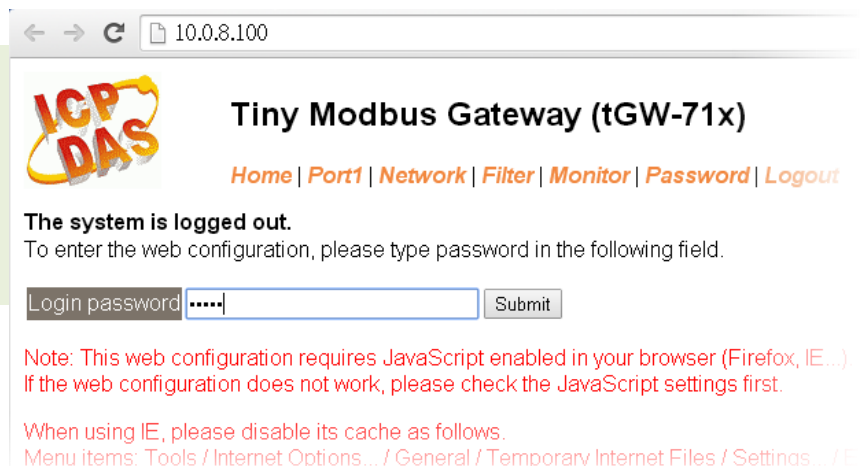
**Step 8:** Enter the URL address of the tGW-700 in the address bar of the browser log in to the Web configuration pages (use the default password **“admin”**).

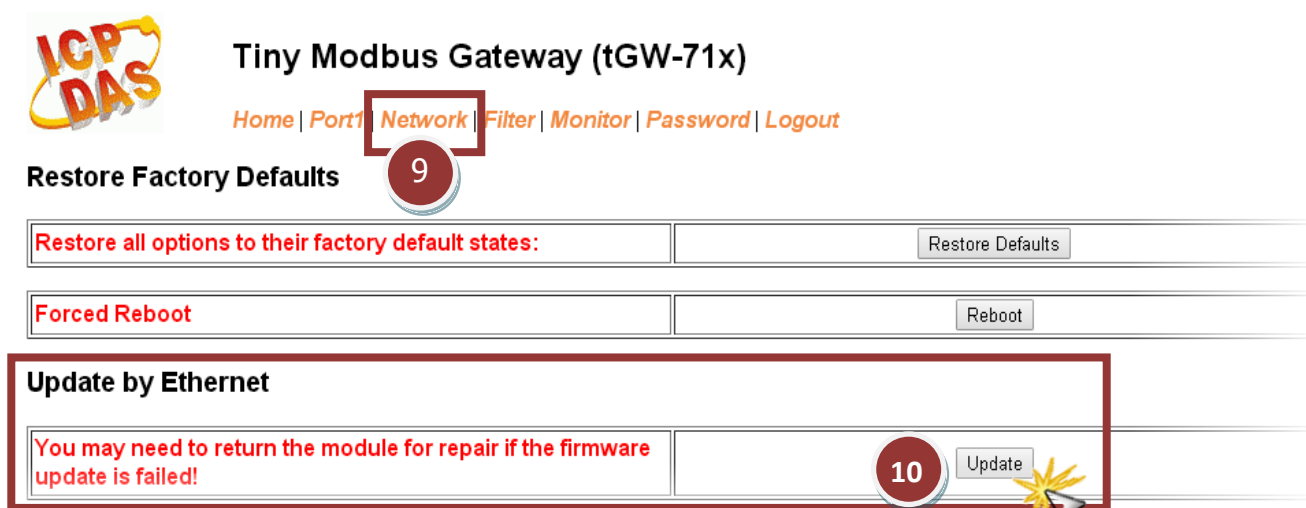
Step 9: Click the **“Network”** tab to display Network and Miscellaneous Settings the page.

Step 10: Click the **“Update”** button in the Update by Ethernet area to start update.

**ICP DAS** Tiny Modbus Gateway (tGW-71x)  
Home | Port1 | **Network** | Filter | Monitor | Password | Logout

**Update by Ethernet**

You may need to return the module for repair if the firmware update is failed! 10

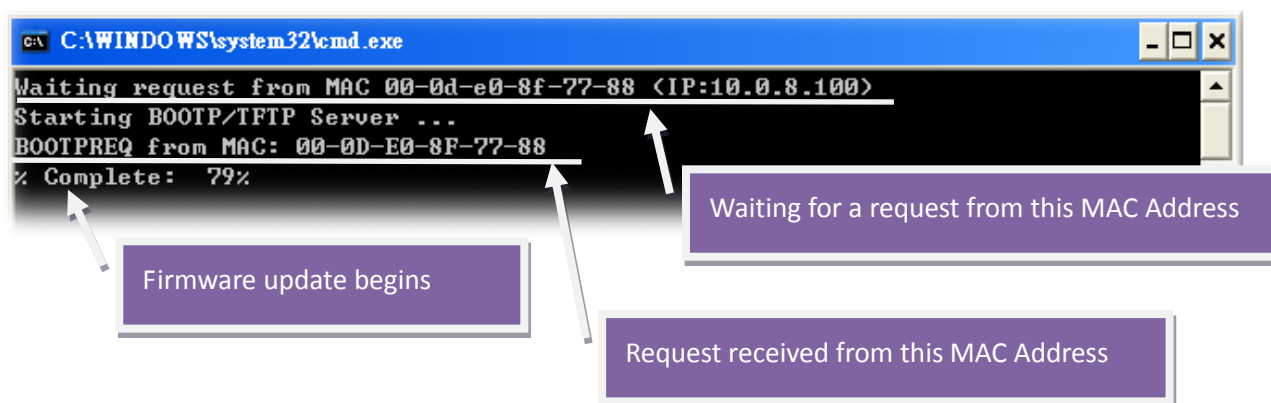
Step 11: Confirm that the two MAC addresses (factory-default): **“Waiting request from MAC x.x.x.x”** and **“BOOTPREQ from MAC: x.x.x.x”** are the same, as indicated below . If these addresses do not match, the update cannot proceed, please refer to *note4 (Page 9)*.

Step 12: Once the update is complete (i.e., when the progress indicator reaches 100%), close this Command Prompt windows.

```
C:\WINDOWS\system32\cmd.exe
Waiting request from MAC 00-0d-e0-8f-77-88 <IP:10.0.8.100>
Starting BOOTP/TFTP Server ...
BOOTPREQ from MAC: 00-0D-E0-8F-77-88
% Complete: 79%
```

Waiting for a request from this MAC Address

Request received from this MAC Address

Firmware update begins

**Note 4:** The “BOOTREQ from MAC: xx-xx-xx-xx-xx-xx” message indicates there is a module with the factory-default MAC address “xx-xx...” that is asking for the firmware to be updated. The update process will not begin if you assign a user-defined MAC address in the firmware update window, since the addresses do not match. If this situation occurs, repeat the update procedure and manually enter the factory-default MAC address in the firmware update window, as described in [Step 5 on Page 3](#). The firmware update procedure is illustrated in the figure below.

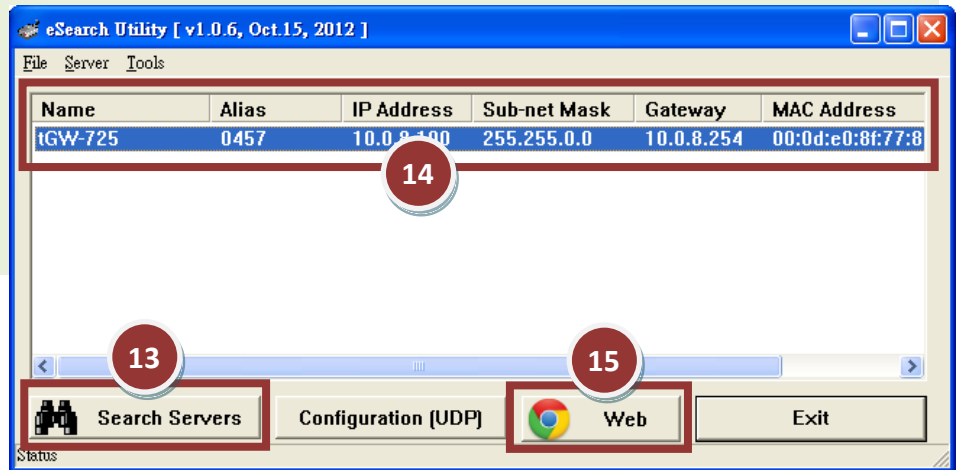
**Step 13:** Run the eSearch Utility and search for the tGW-700 module again to verify that it is functioning correctly. You may need to reconfigure the network settings for the module after updating the firmware. Refer to Step 3 (Page 1).

**Step 14:** Click the name of the tGW-700 module.

**Step 15:** Click the "Web" button.

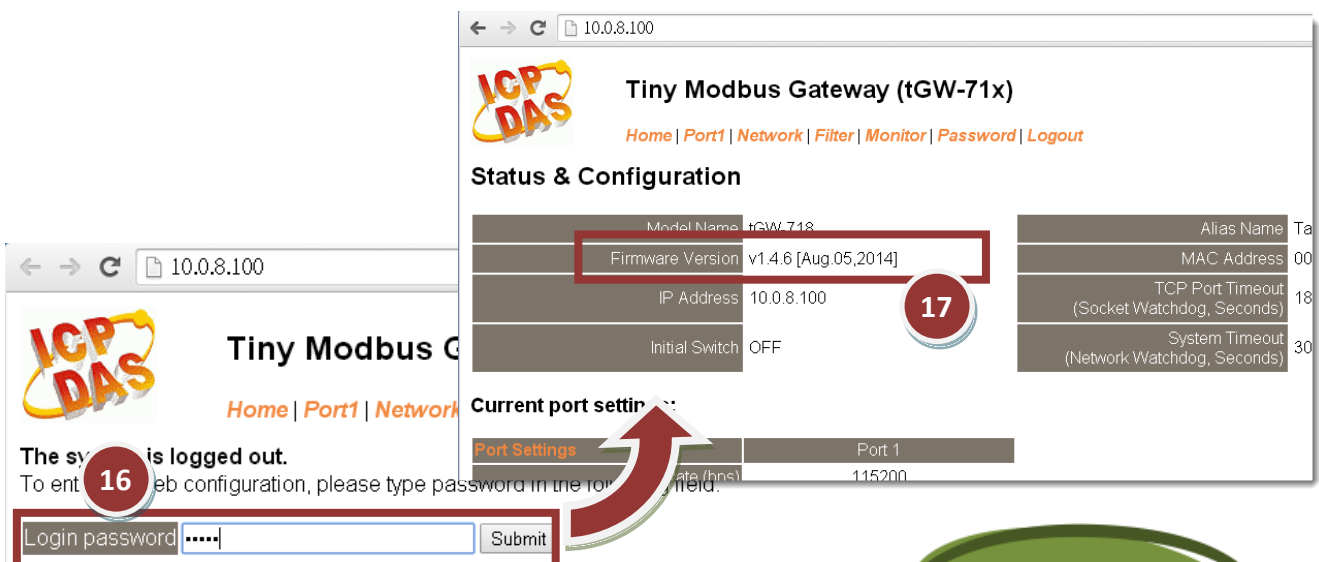
**Step 16:** Log in to the web configuration pages for the tGW-700 (use the default password "admin").

**Step 17:** Verify that the firmware version and date details are correct.

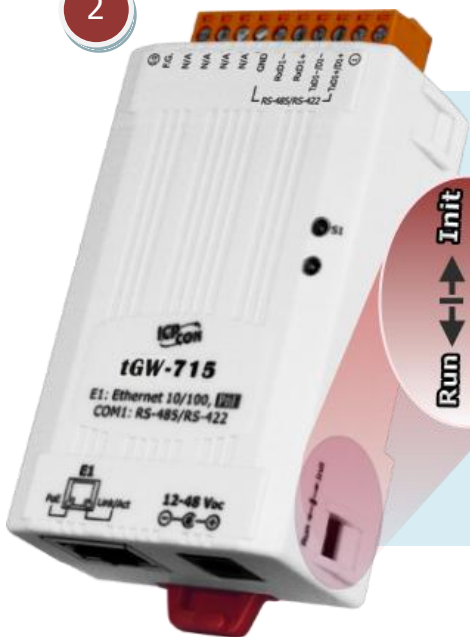
*Step 2: Set the "Init Switch" to the "Init Mode" position.*

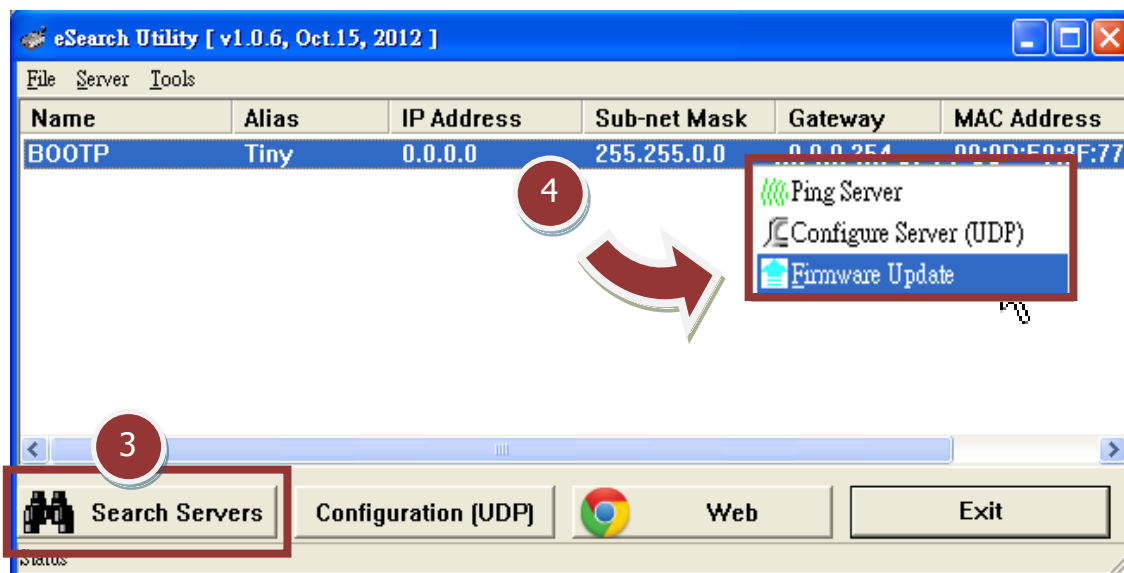
*Step 3: Power-on and reboot the tGW-700 module and then click the "Search Servers" button to search for the tGW-700 at the same time. Note that the tGW-700 module will wait for about 5 seconds for the BOOTP search and firmware update when booting in Init Mode. If this step is not successful, reboot the module and search again.*

Step 4: Right click on the name "BOOTP" and then select the "Firmware Update" item from the popup menu.
